Clayton, Sussex

Church of St John the Baptist

Church fabric
Wall paintings

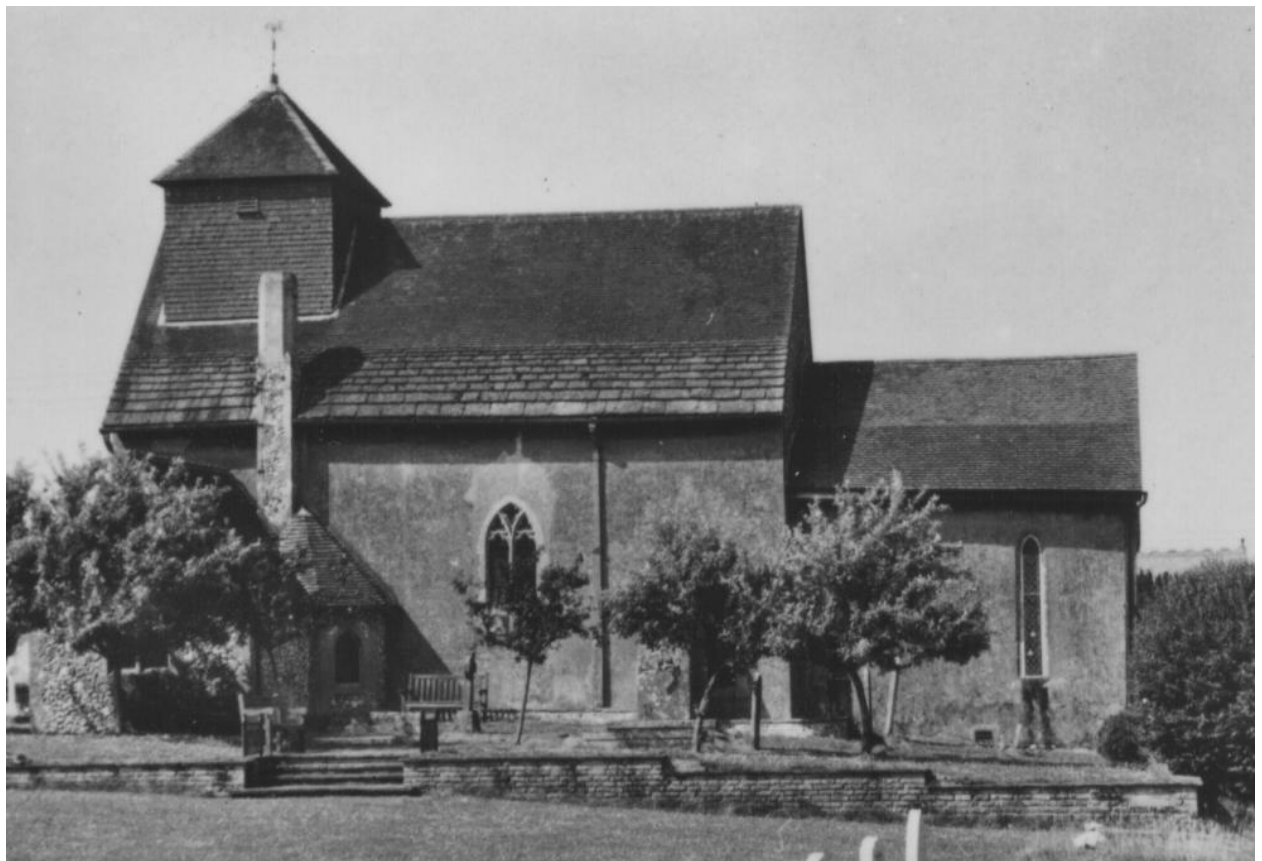
Mostly original except for windows. Exterior N doorway has jambs of upright-and-flat, no impost; arch-head of shaped, regular, segmented stones; almost voussoirs, with wedge-shaped “key stone” slightly to right of centre.

Quoins visible on NE, NW and SW angles; large cut stones, no particular arrangement

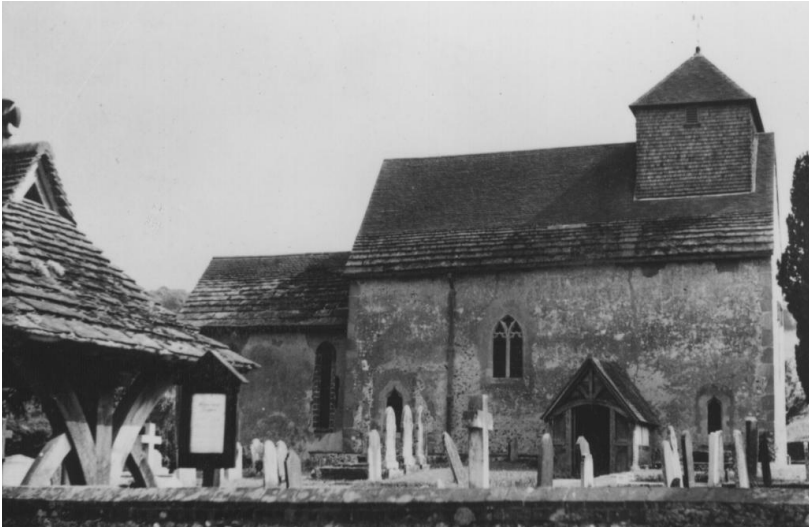
Above: *St John the Baptist, Clayton, view from the north*
Right: *A detail drawing of the impost block and mouldings from the Victoria County History*
Below: *St John the Baptist interior, looking east*

Walls rendered on exterior. Flint wall showing in nave E gable and parts of N wall.
